**HV Power hints and tips:
PQ-Box 100 Power Quality Recorder**

Issue 8a

Connecting to common VT secondary configurations:

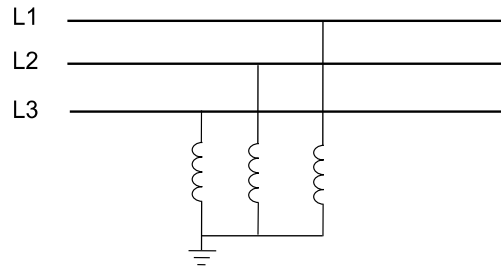
Primary VT connection:

Secondary VT & PQ-Box 100 Connection:

3 Ph Wye +N (grounded neutral)	3 Ph Wye +N (grounded L2)	3 Ph Wye (grounded L2) <small>VT secondary neutral point not available</small>

<p>PQ-Box 100 Setting: 4 Wire</p>

<p>PQ-Box 100 Setting: 3 Wire</p>

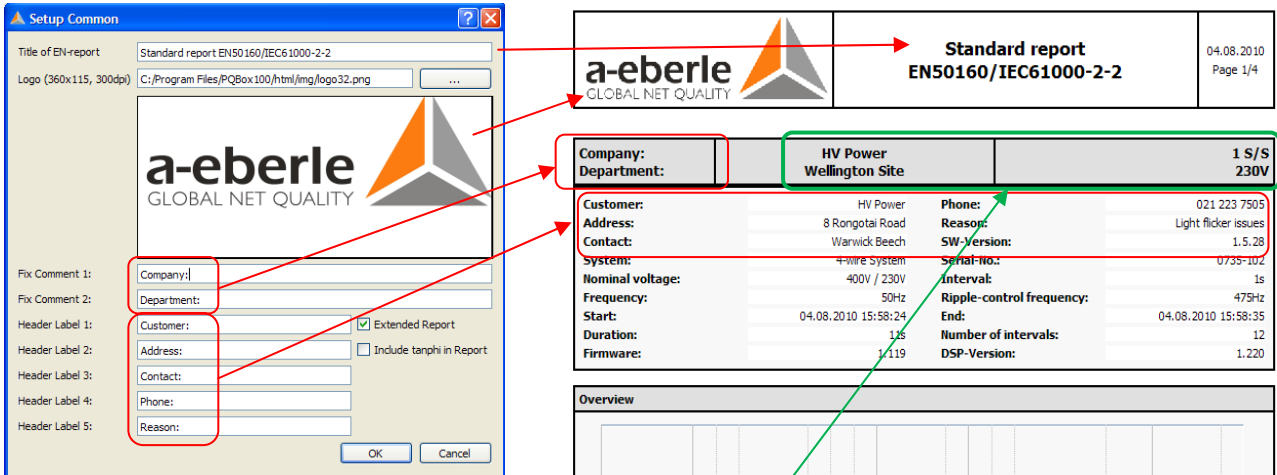
The “Setup Common” dialog box (main menu Setup/Common) sets the default **labels** for *Fix Comment 1 & 2*, and *Header Label 1-5*. These default **labels** are used in the printouts of newly downloaded of data from the PQ-Box 100.

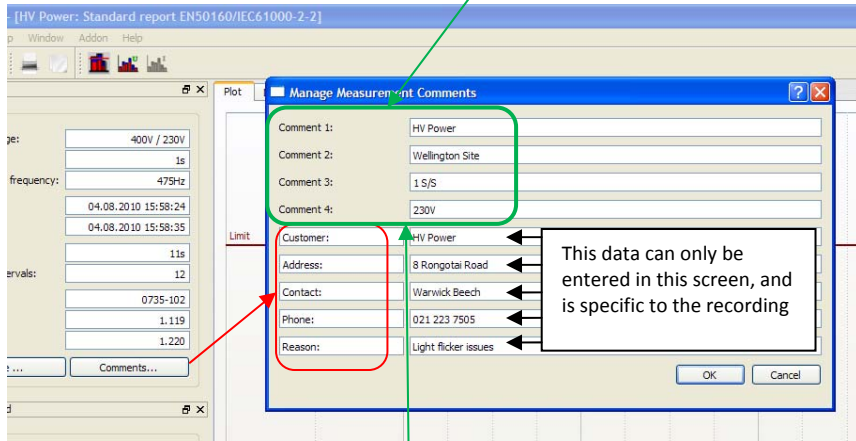
The data for each of these labels can be edited by using the “Comments button”. Additionally the *Header Label 1-5* can also be edited for an individual file, overwriting the label for that specific file only.

Note that the Comment 1, 2, 3 & 4 data shown above “Manage Measurement Comments” dialog box, is the same data that appears in File Load Dialog box (below). This data can be entered or edited in either location.

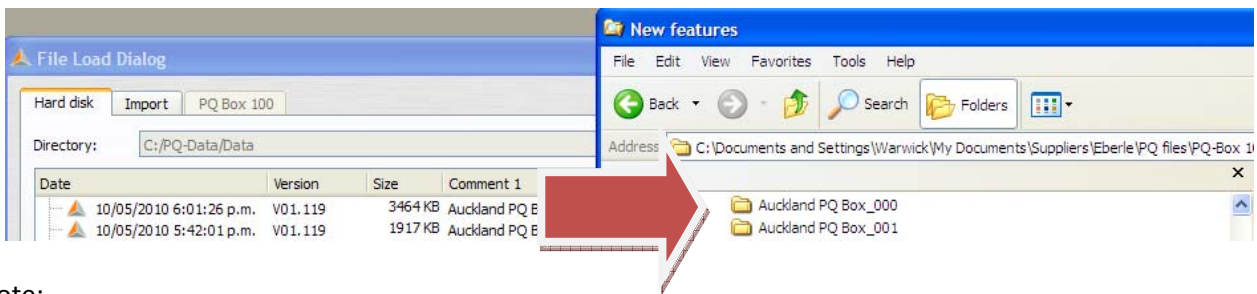
Data folder names and “Comment 1 text”

With WinPQ mobil V1.5.38, the folder created for the downloaded data will be named based on the “Comment 1” text, but suffixed with a sequential number in the format “_000”. This auto assigned suffix allows the “Comment 1” text not to be unique.

If there is no “Comment 1” text entered, then the folder will be named based on the start date/time of the recording, i.e. 20100924_1303_000.

1. If the “Comment1” text is changed within WinPQ mobil software, the the data folder name will be changed as described above
2. If the “Comment1” text is changed outside of WinPQ mobil (e.g. by using Notepad), the data folder name will not be changed when running WinPQ mobil software*
3. If the data folder name is changed outside of WinPQ mobil software, the data folder name will not be changed when running WinPQ mobile software*
